Title	Revision	Date	Page			
	Measuring PQ Issues in a Bus Depot Using Unipower HW and Software				R3	20-Feb-2025	1(4)
	Туре	Signature	Checked	File	I		
	Case Study	то	PSA	Case Study, Electrical bus depot in Sweden

Introduction

This case study explores how advanced power quality measurement technology facilitated the diagnosis of severe power quality disturbances in a bus depot. These disturbances, which neither the bus operator nor the bus manufacturer initially attributed to electrical quality issues, were ultimately traced to deficiencies in the depot's charging infrastructure.

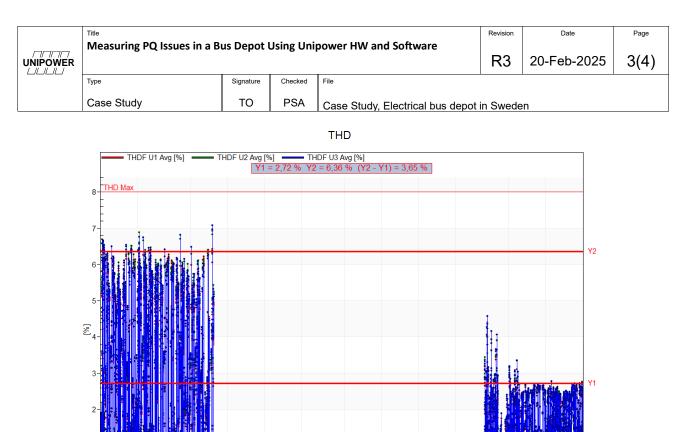
• **Substantial reduction in harmonic distortions**, bringing them within regulatory compliance limits.

Figure 3: THD before and after filters were installed

Following the identification of these power quality issues, the DC charger manufacturer installed appropriate electrical filtering solutions. A subsequent measurement campaign was conducted to assess the effectiveness of these interventions. The results demonstrated a significant improvement:

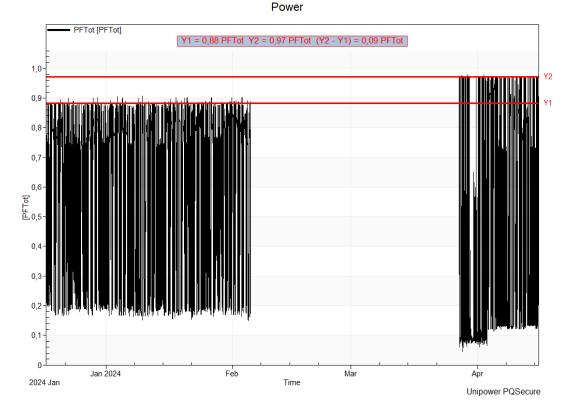
Additionally, the analysis revealed that the power factor was significantly below optimal levels, causing energy inefficiencies within the depot's electrical distribution system.

Power factor improvement from 88% to 97%, enhancing overall energy efficiency by 9%.

Figure 4: Power factor before and after filters were installed
